**RESEARCH AND DEVELOPMENT TESTING
OF YTTRIA/RARE EARTH
STABILIZED ZIRCONIA MATRIX BRICKS
IN THE PILOT TEST UNIT (PTU) AT AEDC**

C. R. Tinsley

ARO, Inc.

November 1972

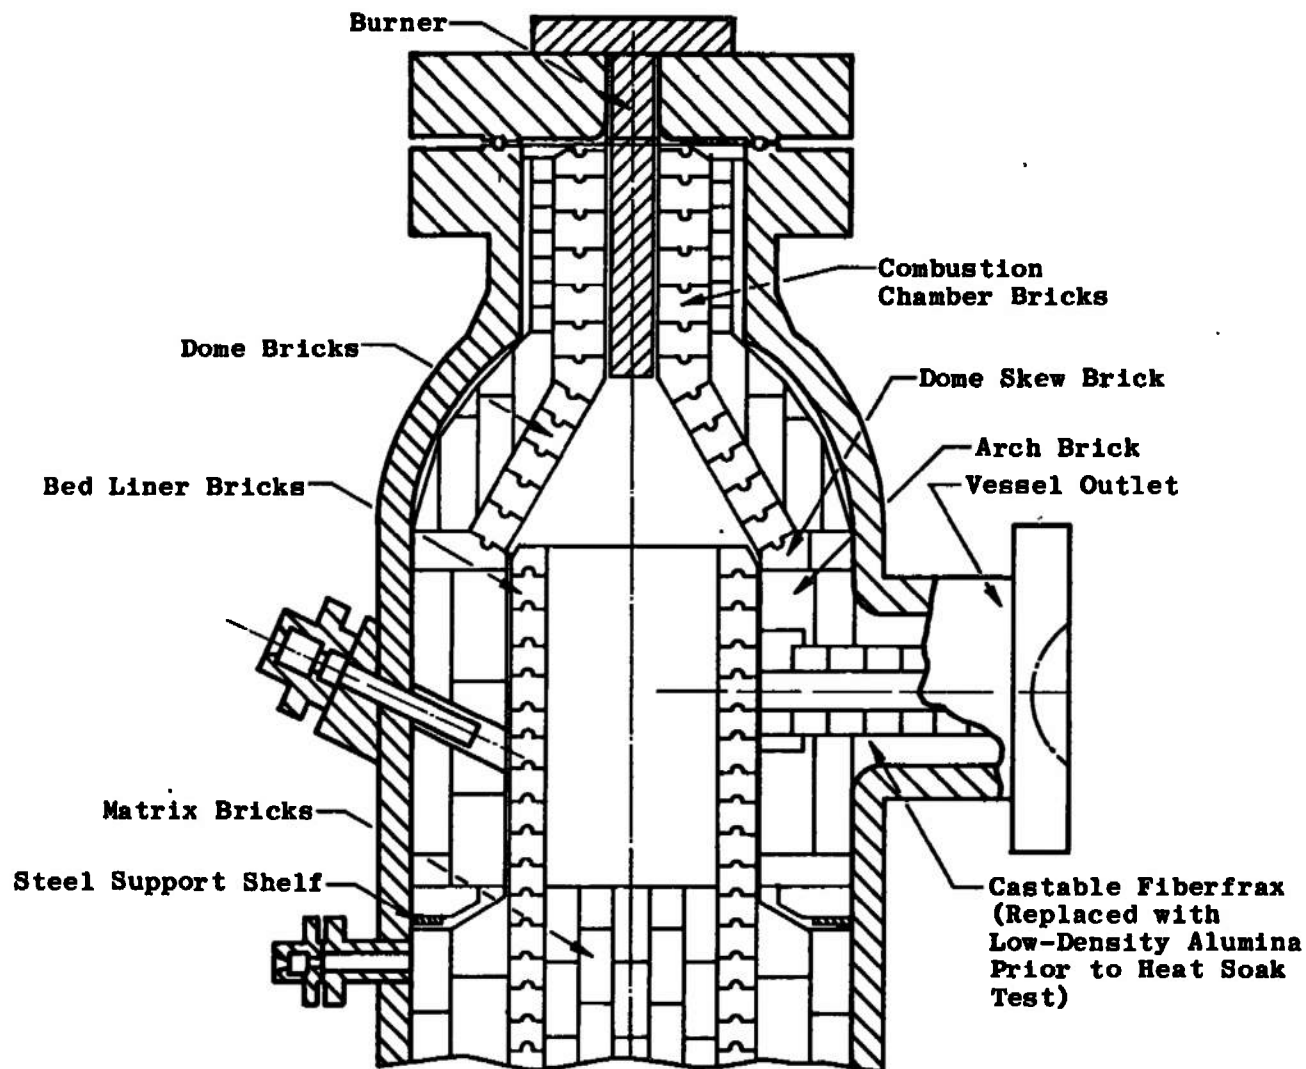
Fig. 8 Schematic of Heater Dome and Combustion Chamber Area

Visual inspection of the heater combustion chamber bricks and arch bricks adjacent to the dome skew bricks (see Fig. 8) revealed fracturing, spalling, and crumbling in these areas. However, replacement of the refractories was not deemed necessary.

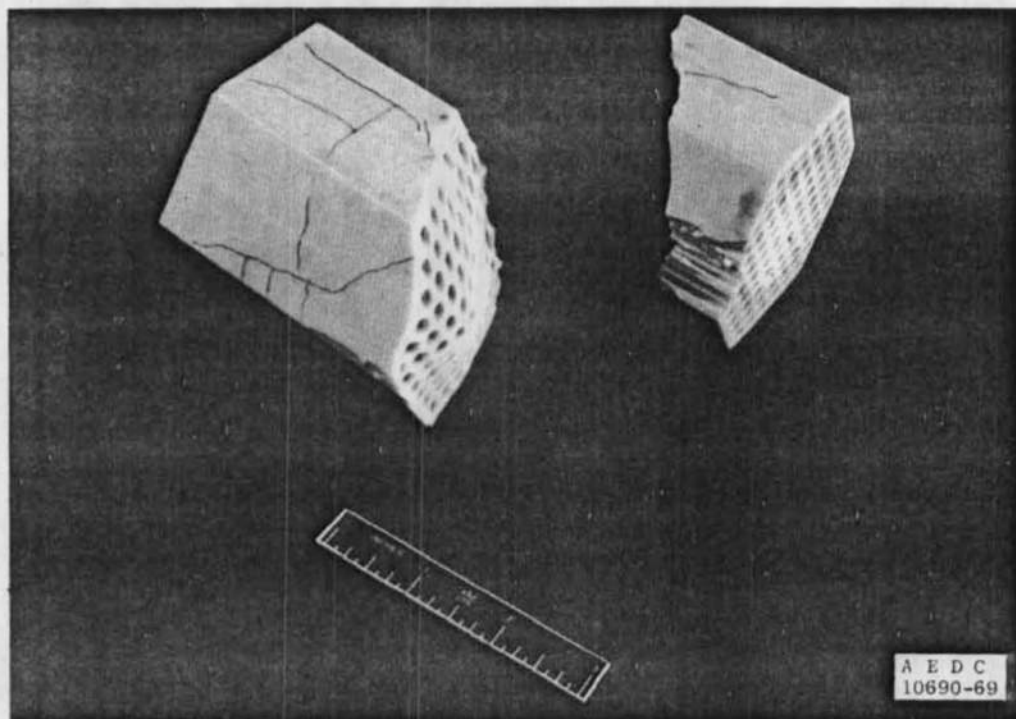
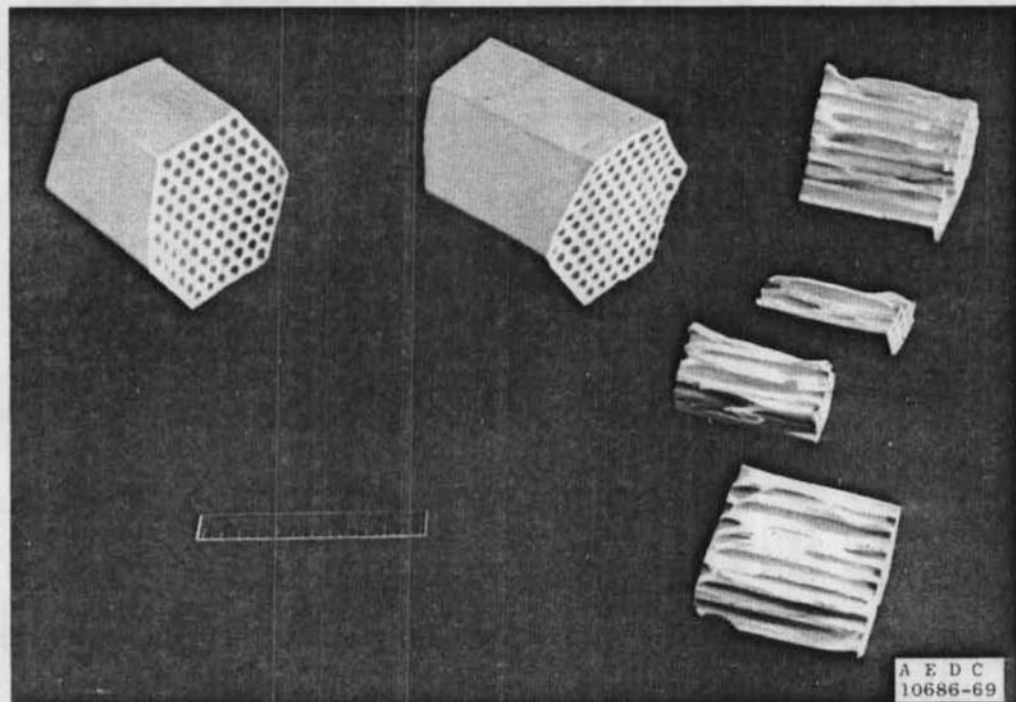
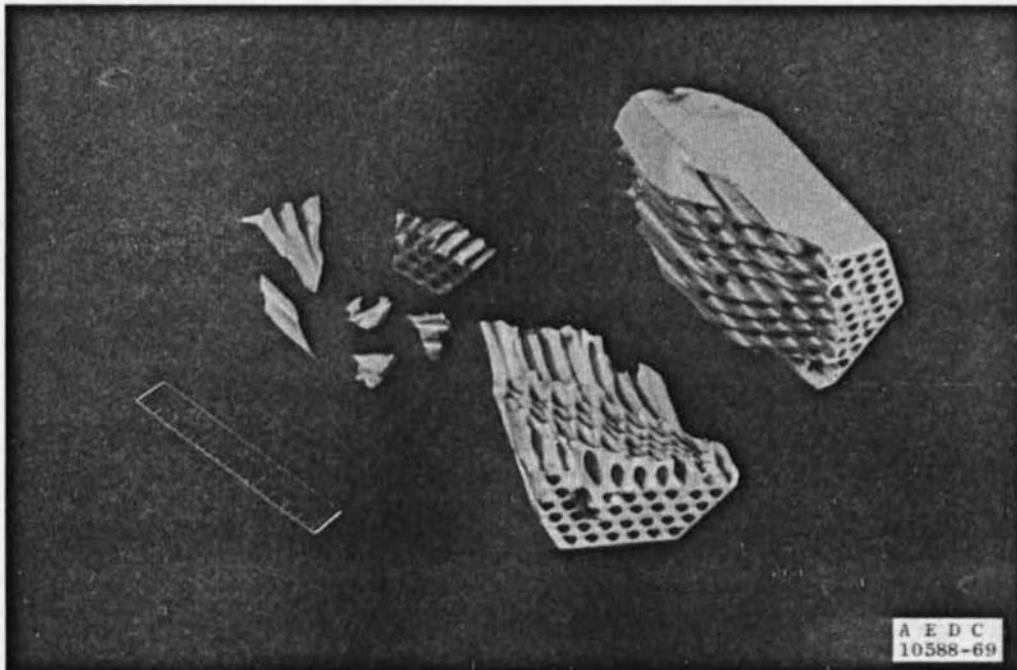
Inspection of the matrix revealed that excessive fracturing and cracking had occurred as a result of the reactant flow anomaly. Of particular note was the tendency of relatively long bricks to fracture into shorter segments. All matrix bricks inspected including the original cored bricks were hard indicating no destabilization. Pertinent photographs taken during the inspection are presented in Fig. 10.

b. Brick Placed into Matrix Pre-Heat Soak, Column 1, 9.25 w/o, Coors

c. Brick Placed into Matrix Pre-Run 28, Column 13, 10.9 w/o, Coors
Fig. 10 Continued

d. Brick Placed into Matrix Pre-Run 28, Column 16, 13.8 w/o, Coors

Prior to run 33, additional sample bricks with 10.9, 12.6, and 13.8 w/o yttria were added to the matrix to replace the broken ones and to level the bed at a nominal height of approximately 15 ft (measured relative to the grate). The orientation of these bricks in the matrix is presented in Fig. 11.

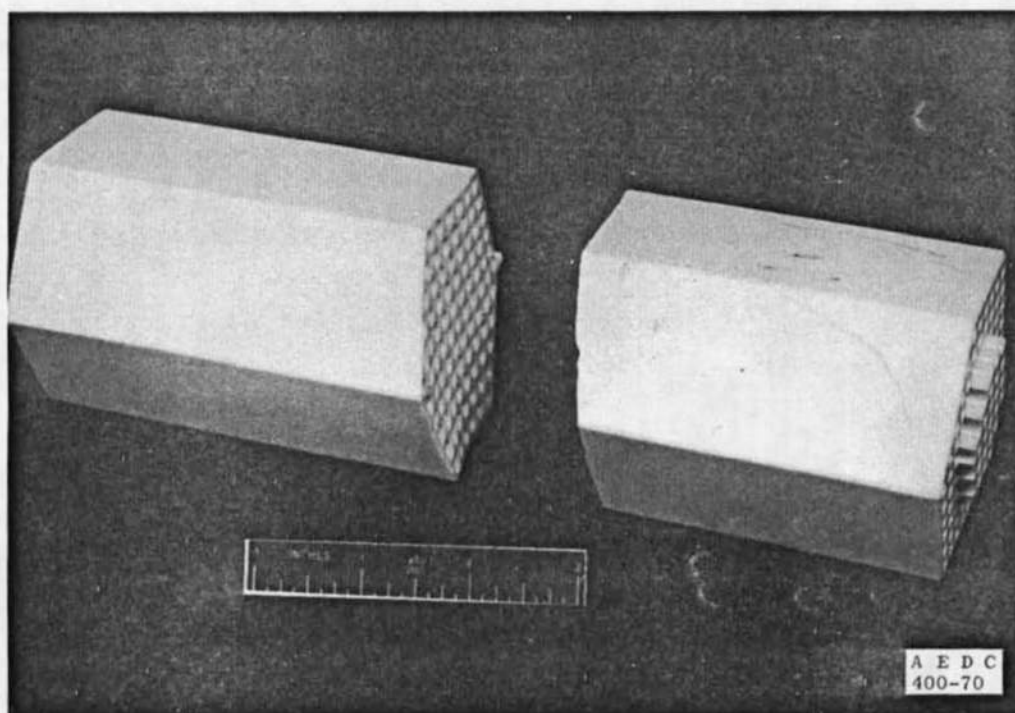
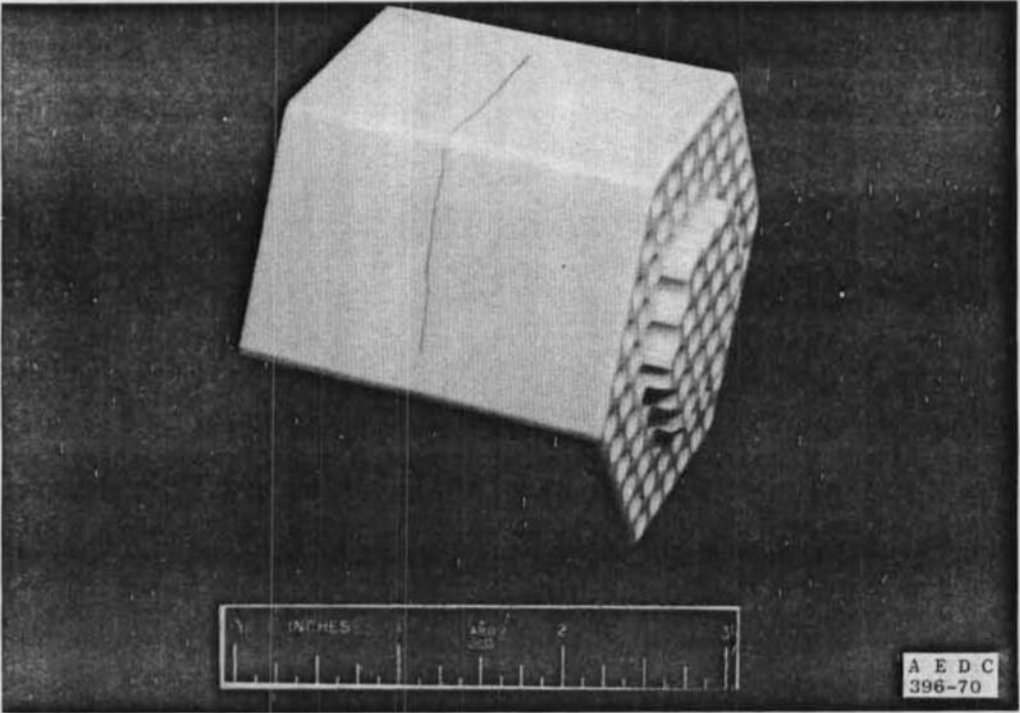
Inspections after run 37 revealed (1) that the sample matrix bricks installed before run 33 were in good condition with some hairline cracking and (2) that heater combustion chamber insulation refractories exhibited further degradation. Pertinent photographs taken during the inspection are presented in Figs. 12 and 13.

a. Column 13, 10.9 w/o, Coors

c. Column 7, 13.8 w/o, Coors
Fig. 12 Concluded

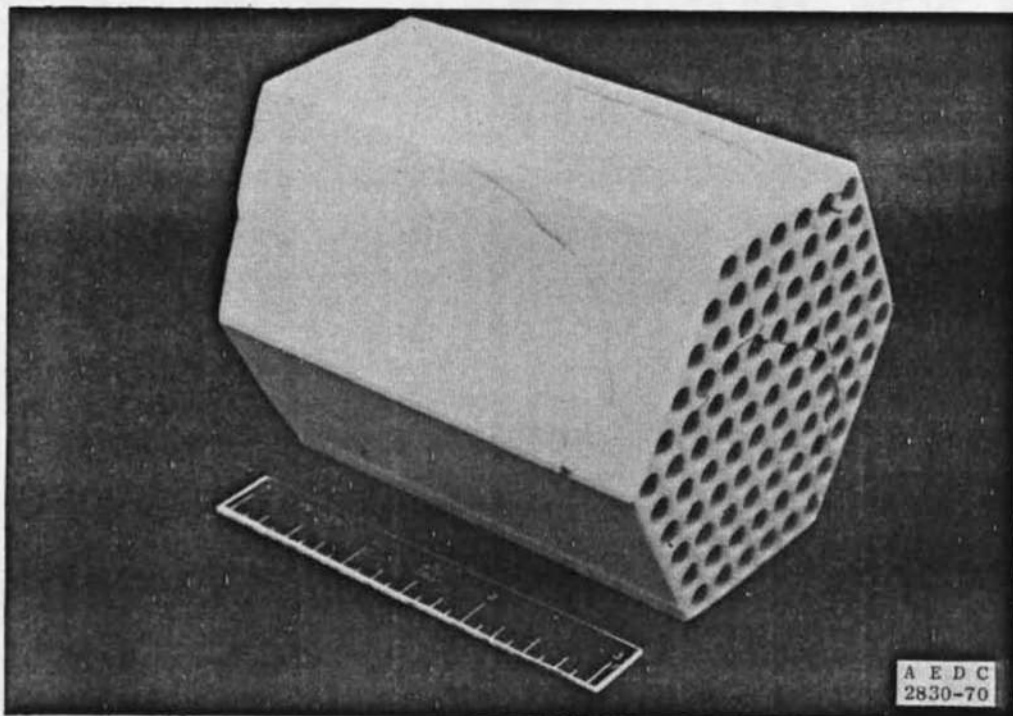
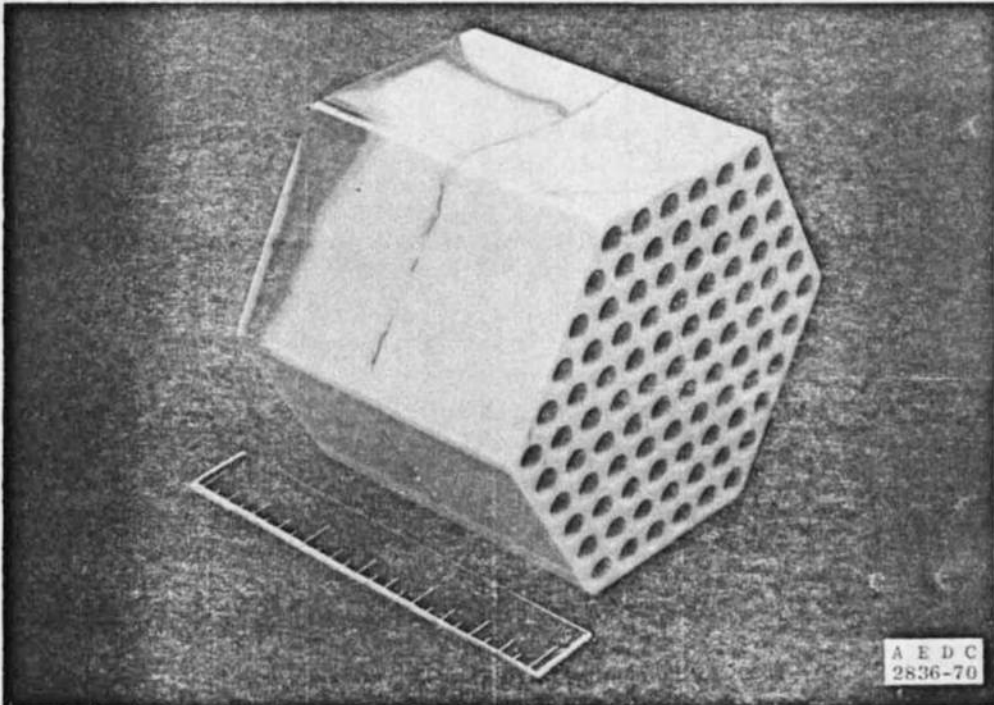
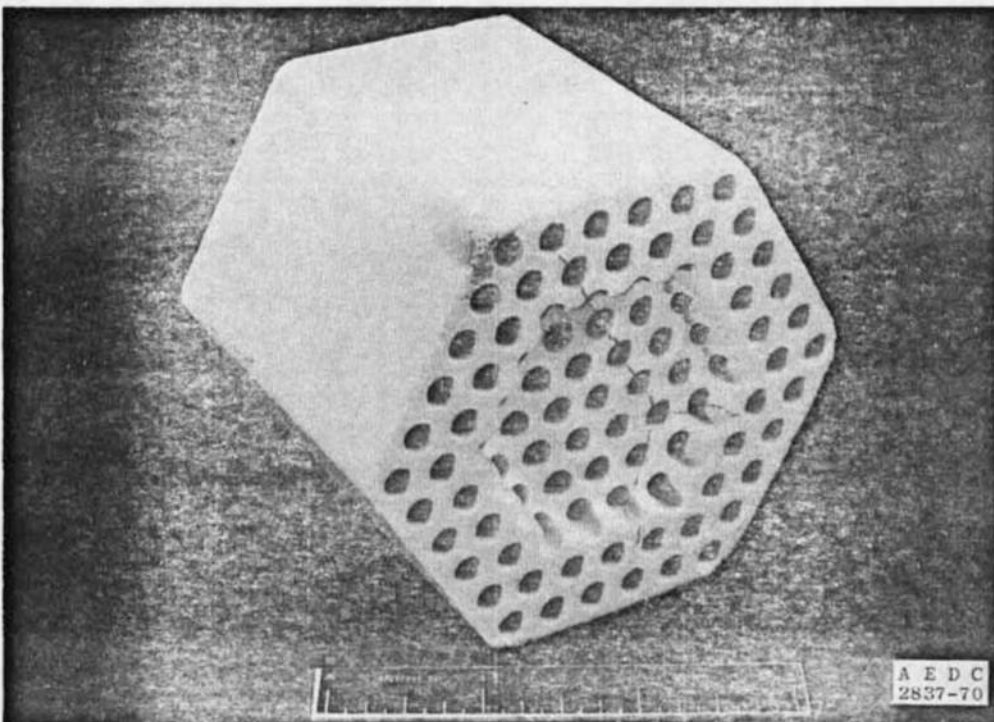
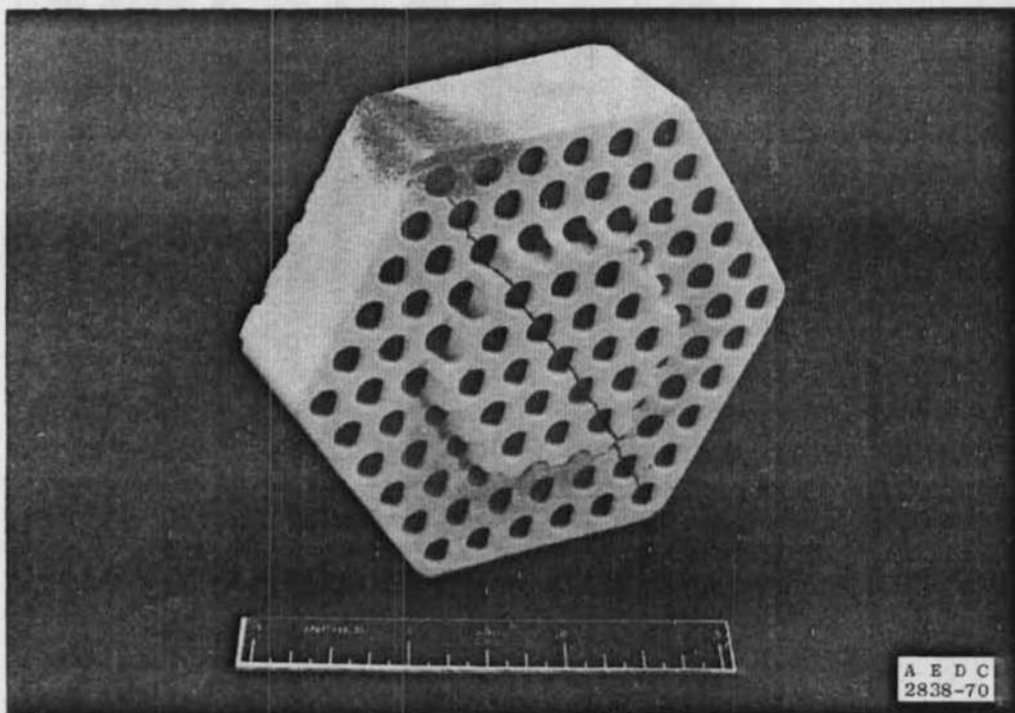
Posttest 38 inspections revealed (1) that nitric acid erosion was the prime factor causing burner deterioration and (2) that selected matrix bricks inspected were in good condition with only a few additional hairline cracks. Pertinent photographs taken during the inspections are presented in Fig. 15. The bricks depicted in Figs. 15a and b were also photographed after run. 37 (see Fig. 12) so that the effects of testing could be documented in typical matrix bricks.

a. Column 13, 10.9 w/o, Coors

c. Column 7, 13.8 w/o, Coors

d. Zircoa, Low Density, 12.5 w/o, Posttest 38 (Upper Block)
Fig. 15 Continued

e. Lower Block
Fig. 15 Concluded

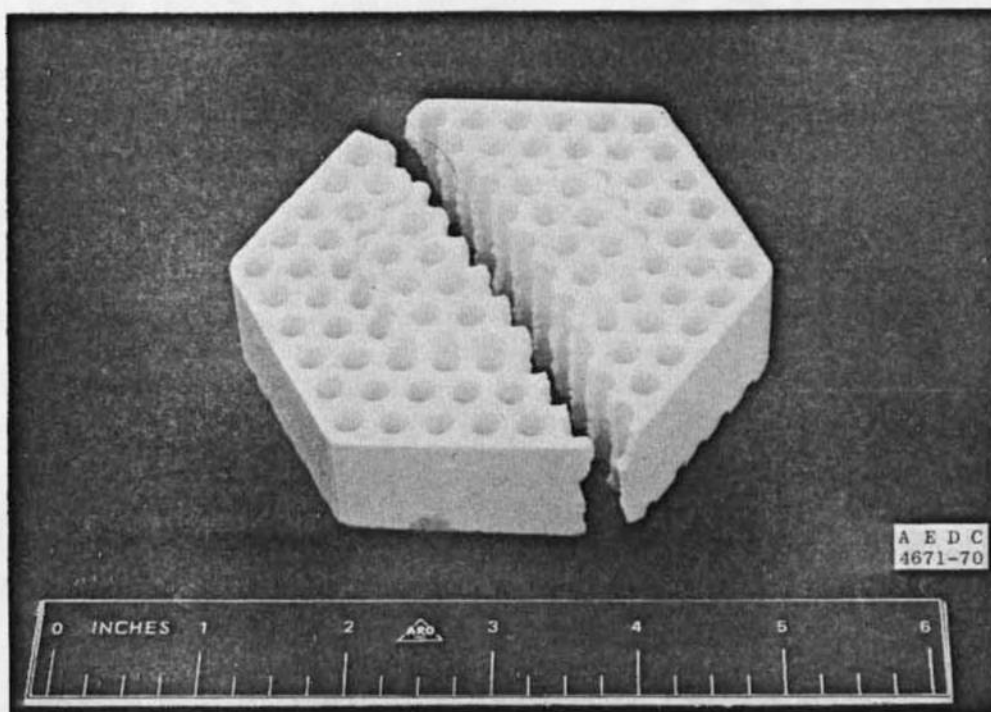
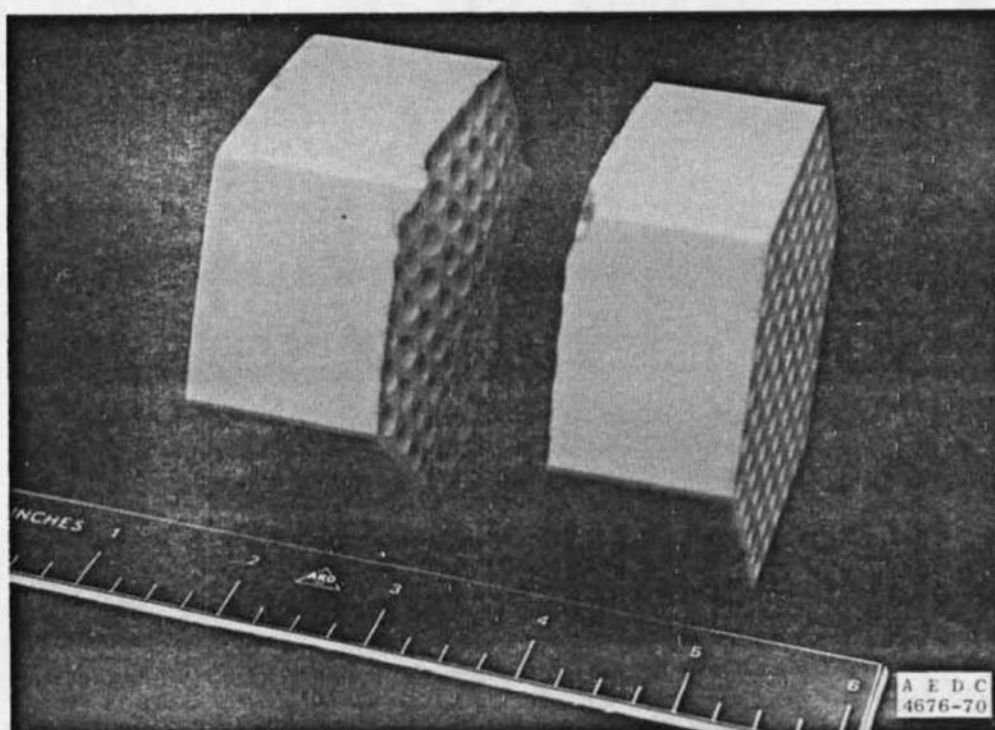
Inspection of selected matrix bricks revealed them to be in good condition and practically unchanged since inspected after test 38. Pertinent photographs taken during the inspection are presented in Fig. 16. The matrix bricks presented in Fig. 16 were also photographed after test 38 (Fig. 15).

b. Zircoa, Low Density, 12.5 w/o, Lower Block

c. Column 7, 13.8 w/o, Coors
Fig. 16 Concluded

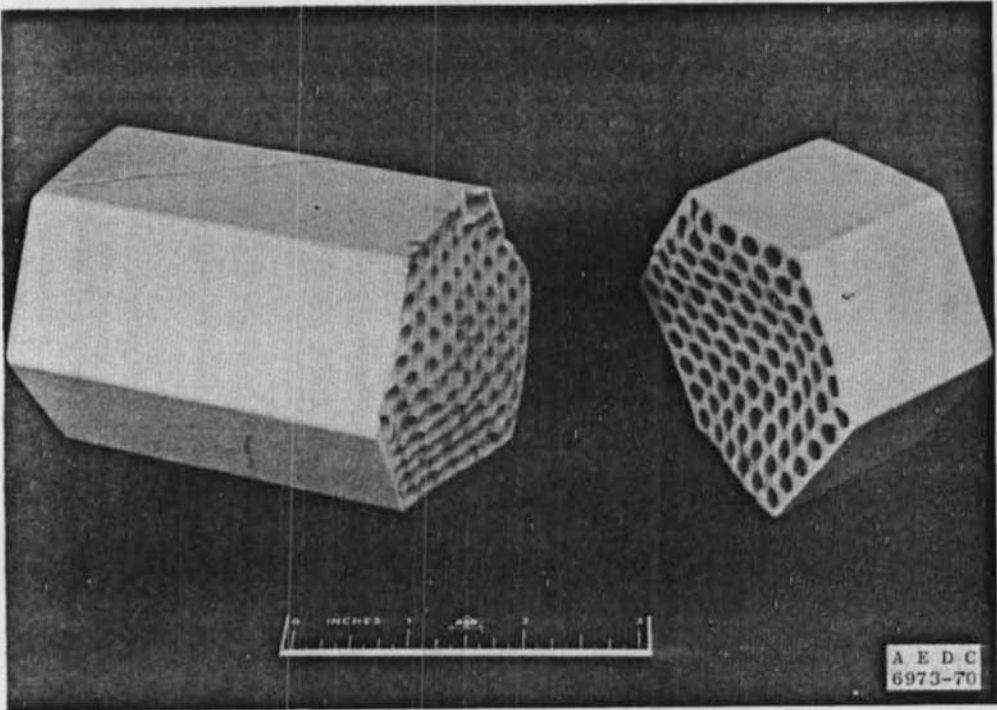
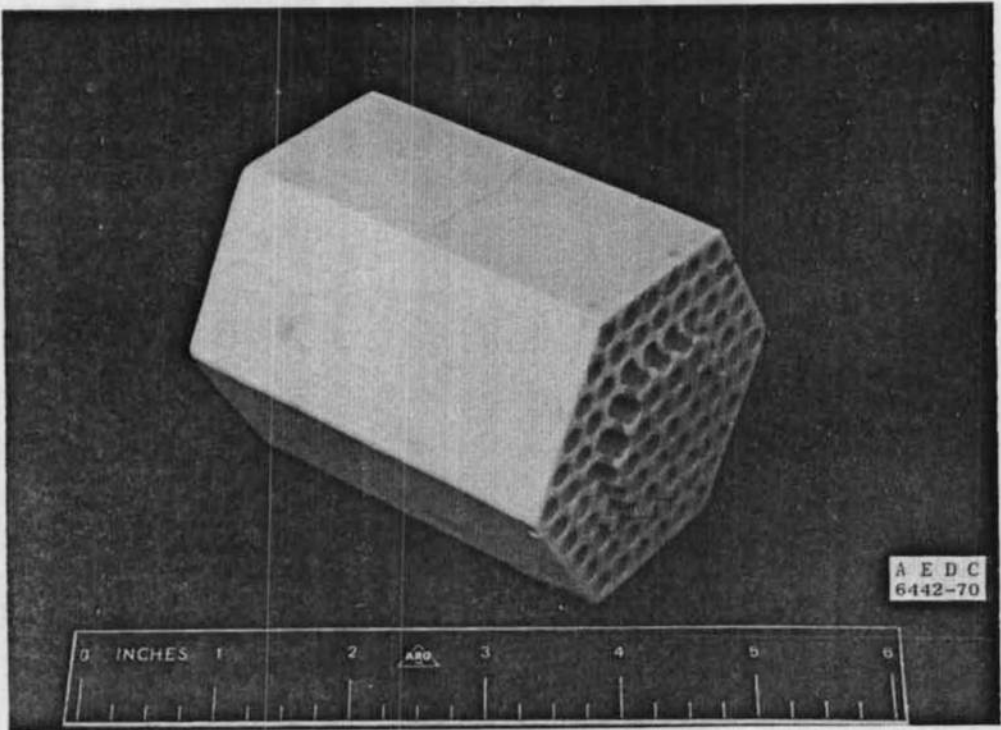
After runs 40 through 44, the top foot of the cored matrix was removed for the first major inspection. Laboratory analysis of selected bricks did not indicate destabilization. Pertinent photographs taken during the inspection are presented in Fig. 17. By referring to Fig. 14, all bricks shown in Fig. 17 can be identified as to location and number of runs that they remained in the matrix.

a. Column 10, 10.9 w/o, Coors

b. Column 8, 12.6 w/o, Coors
Fig. 17 Post-Run 44 Matrix Inspection

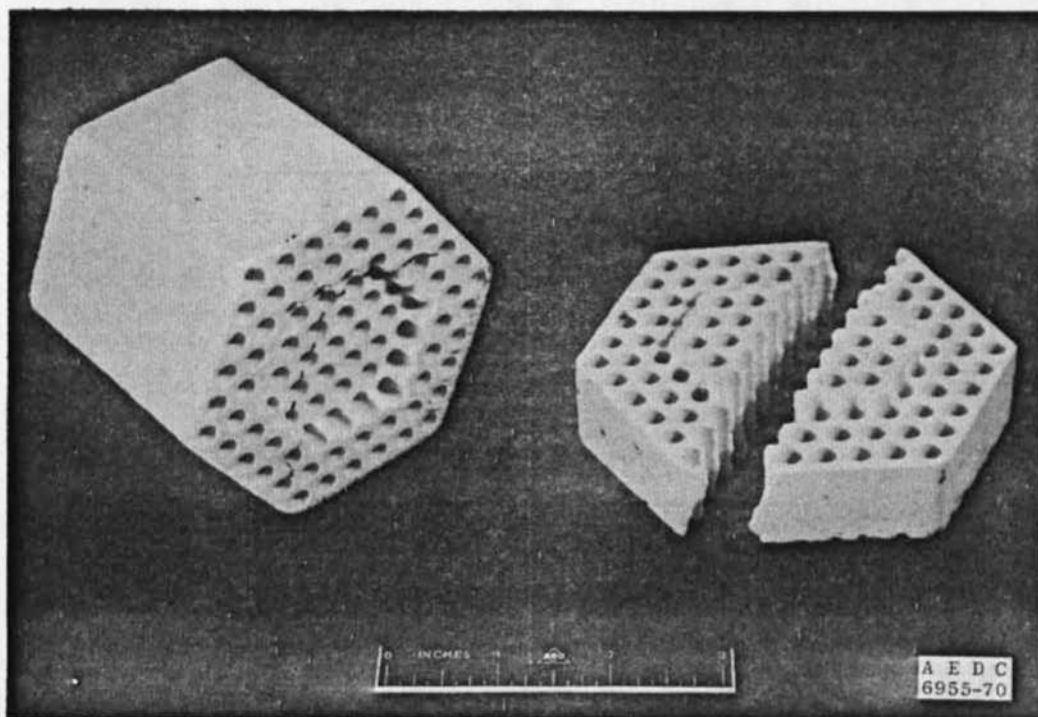
h. Zircoa, Low Density, 12.5 w/o
Fig. 17 Concluded

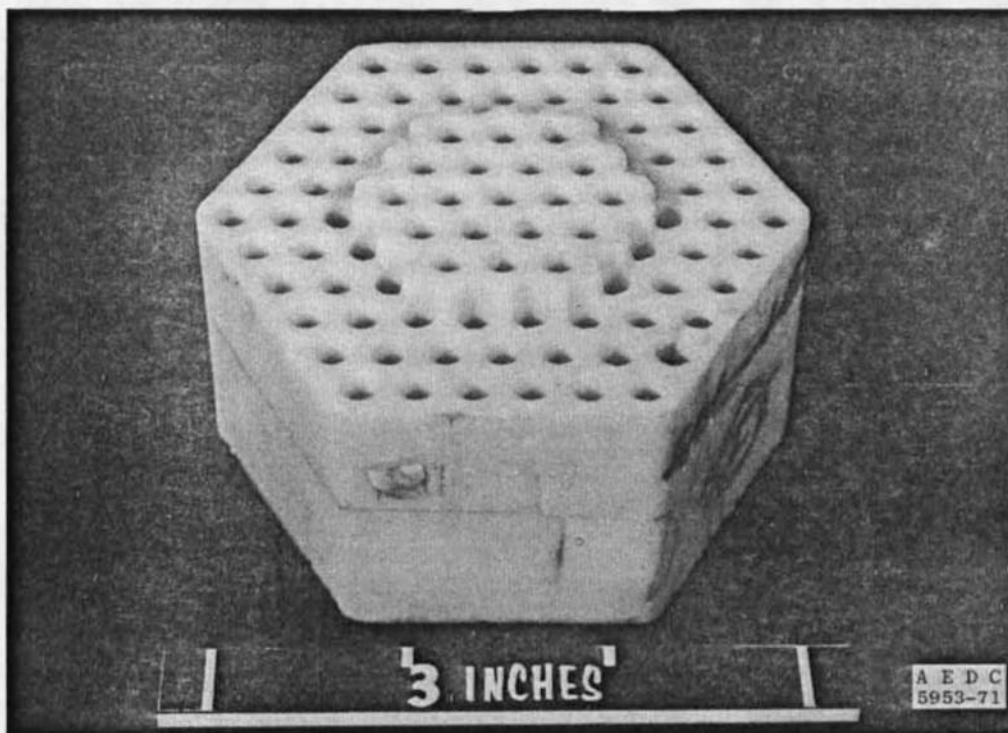
g. Zircoa, 16.5 w/o, Location 18-7

Throughout the pilot heater test program, fusion of the zirconia bricks has been noted. Occasionally, a small brick particle or chip was found fused inside a brick air passage, or a piece of one brick was sometimes found fused to the side of another brick, as illustrated in Fig. 23g. Also two or more bricks were sometimes found fused together. A sudden shock will usually separate the two. A typical example of this type of fusion is shown in Fig. 24d.

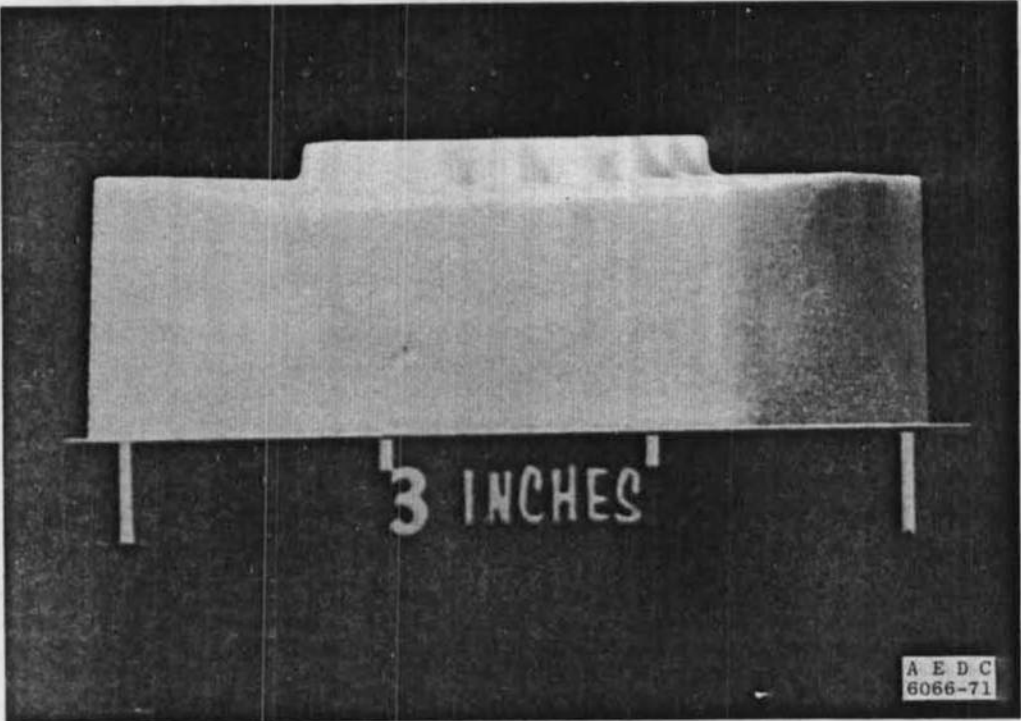
d. Zircoa, 14.5 w/o, Location 11-3 and 11-4

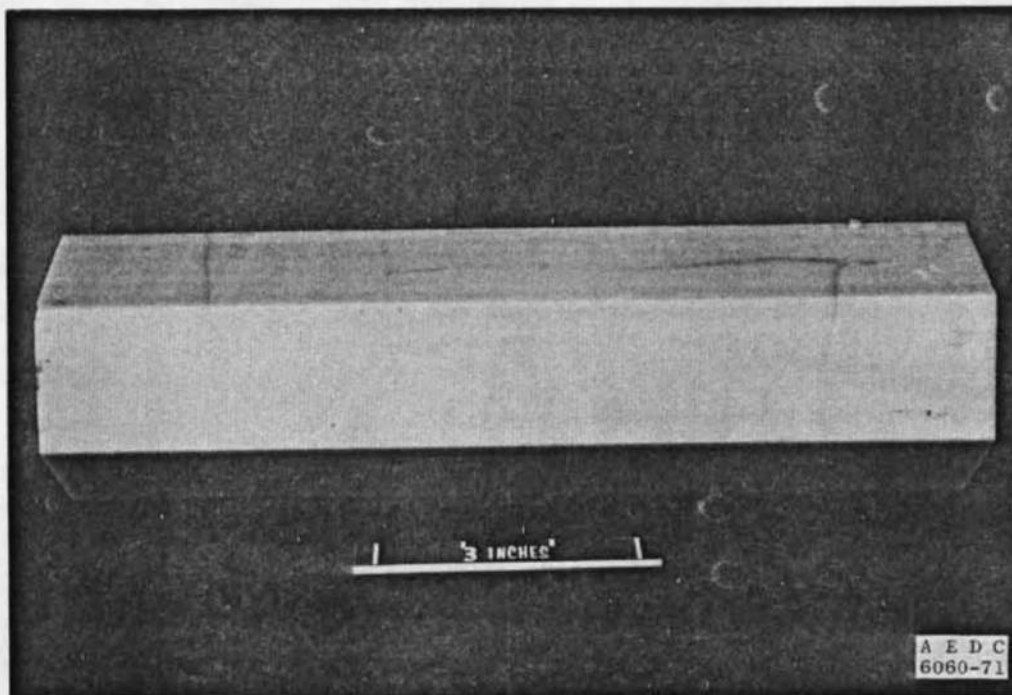
a. Coors, 9.25 w/o, Column 3, 14.5-ft Bed Level

Presented in Fig. 26 are three matrix bricks which were located directly below the sample bricks in their respective columns. The brick shown in Fig. 26a was located in matrix column 3 (the center column) and was placed in the matrix before the heat soak. Except for the sample bricks, the condition of this brick was better than any of the zirconia bricks. This is a Coors brick stabilized with 9.25 w/o yttria.

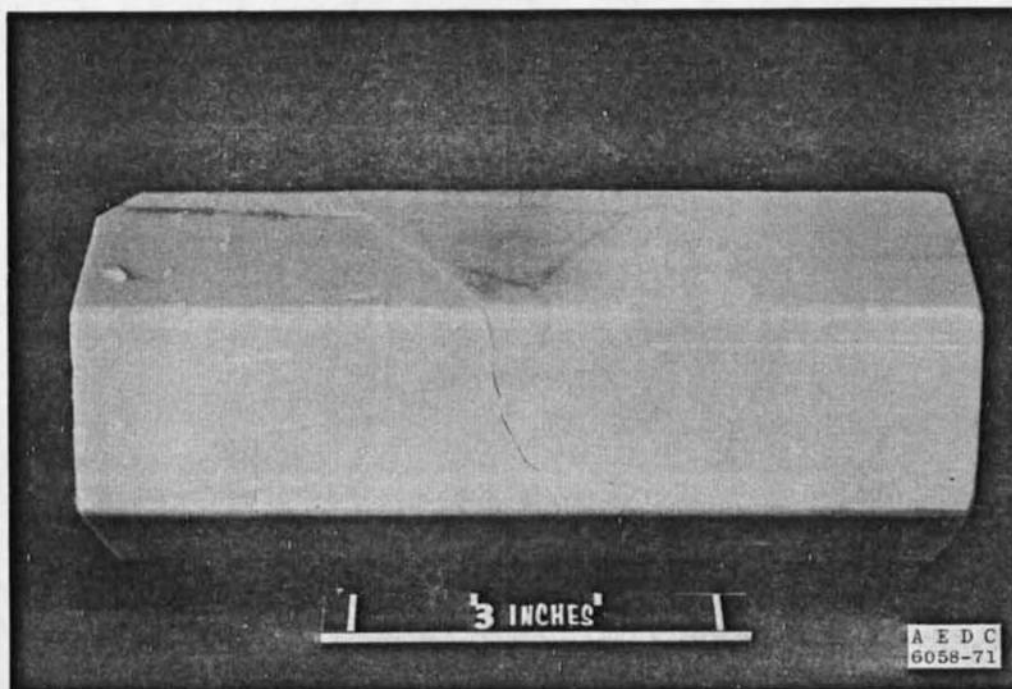
b. Coors, 10.4 w/o, Column 11, 14.5-ft Bed Level

Shown in Fig. 26b is another Coors brick which was placed in the matrix before the heat soak. This brick is stabilized with 10.4 w/o yttria and was located directly below the sample bricks in matrix column 11.

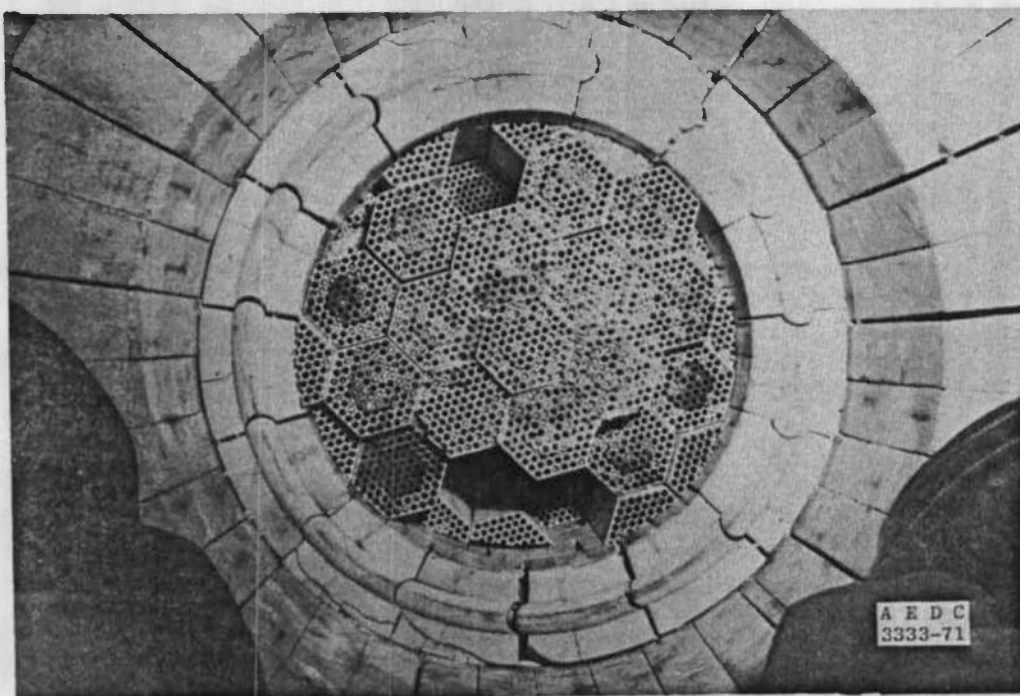
The top course of alumina bricks at the zirconia/alumina interface was removed from the matrix. Brick length was approximately 11 in. A photograph of the alumina matrix at the interface is presented in Fig. 27a. Three of the alumina bricks had been removed from the matrix before the photograph was taken. During removal of the top course, seven bricks located centrally in the matrix were fused together and were removed as a unit. A photograph of these bricks is presented in Fig. 27b. It is evident in Figs. 27a and b that, at the interface, the centrally located bricks had become plastic and distorted as a result of high temperature. This distortion was only present at the top surface of the bricks. Presented in Figs. 27c through e are additional photographs of alumina bricks from the top course. These photographs are presented so that crack and fracture patterns in the alumina bricks may be observed.

a. Alumina Upper Surface at the Zirconia/Alumina Interface
Fig. 27 Alumina Matrix, Post-Run 85

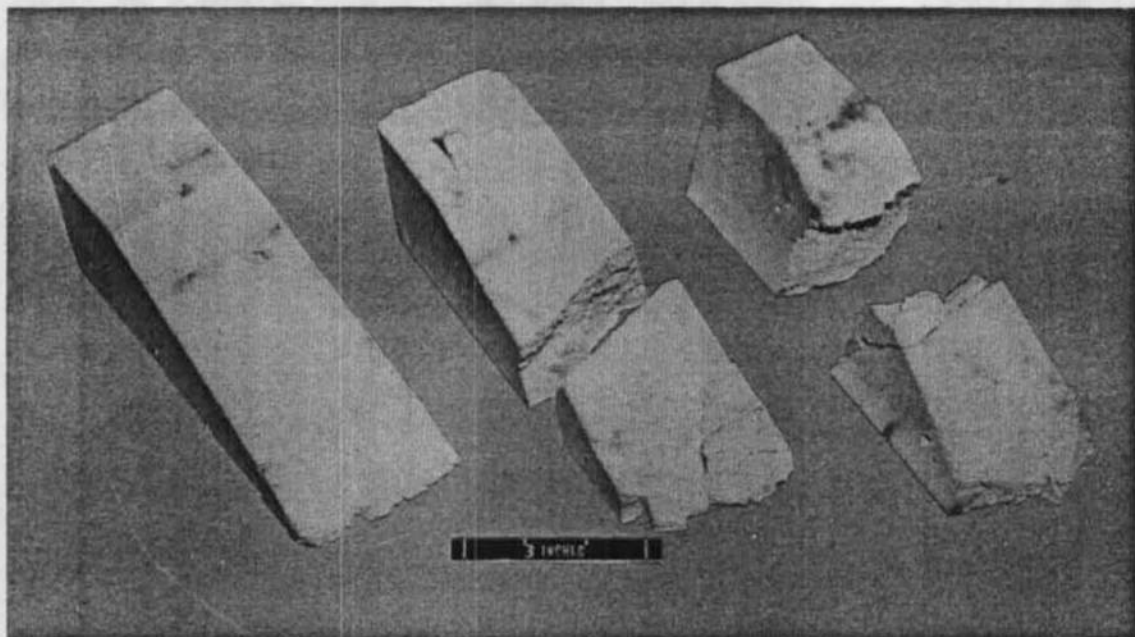
Presented in Fig. 28 are photographs of various heater insulation refractories taken during the removal process. The condition of typical dome hot face refractories is illustrated in Fig. 28a. The steel shelf may be noted in Fig. 28b along with the bed liner bricks and the first layer of insulation. The outer layer of insulation cannot be seen in this photograph because of the heater shelf. Presented in Figs. 28c through h are photographs of various heater insulation and liner bricks. Crack and fracture patterns shown in these bricks are typical for the various types of insulation refractories.

c. Typical Dome Insulation, Lightweight Fully Stabilized Calcia Zirconia

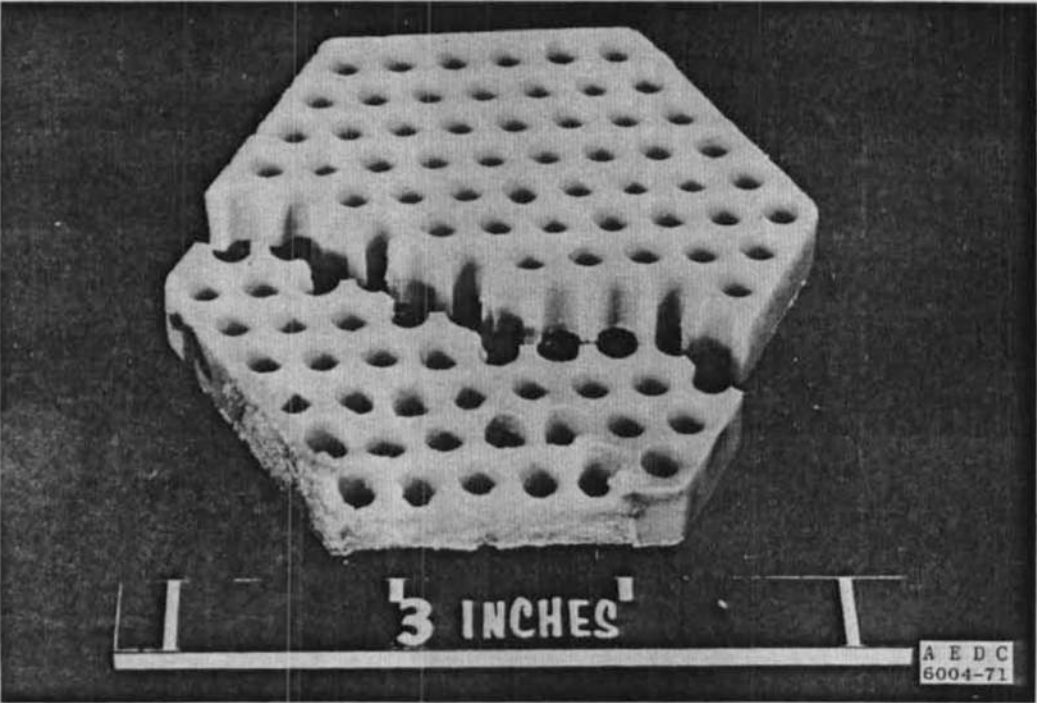
a. Coors, Buffer Brick, Column 10

Presented in Fig. 31 are matrix bricks, photographed during the post run 85 inspection, upon which material has been deposited and/or removed. The composition of material in these areas was analyzed and found to vary only slightly from the remainder of the bricks. Bricks which possessed this appearance were as follows: brick numbers 10-1, 10-2, 10-3, 12-2, 12-3, 13-5, 13-6, and 16-5. All of these bricks were situated in matrix columns adjacent to the bed liner. Brick 10-1 (Fig. 31a) appears to have experienced localized melting, resulting in the removal of material from the brick. To a lesser extent, this may also be observed of brick 13-6 (Fig. 31b). Presented in Fig. 31c are bricks 10-2 and 10-3 which are fused together. Again a localized area of the brick appears to have melted. In addition, deposits of yttria/zirconia material are fused to the bricks.

Fig. 31 Bricks Exhibiting Localized Fusion and/or Material Deposits, Post-Run 85

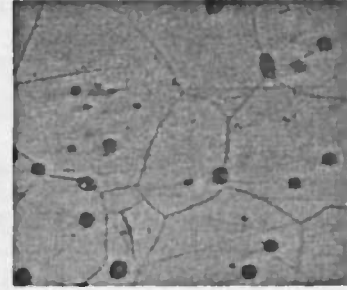
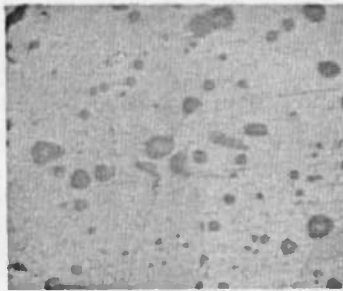
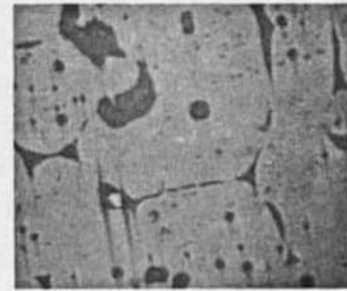
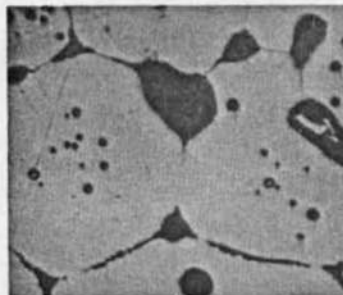
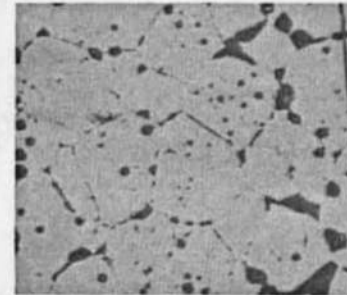
Fig. VII-1 Photomicrograms of Stabilized ZrO_2 Cored Block Samples

Photomicrographs of cored block polished sections are shown in the composite of Fig. VII-1. The ZrO_2 materials at the top of the bed (14- to 15-ft-level) exhibit large equiaxed grains containing microstructures, a condition indicative of exposure at high temperatures. Pores also have become more rounded and larger as expected. No solid second phase is apparent. In the midportion of the ZrO_2 bed (11- to 12-ft-level), the microstructure

a. 10.8-Percent $\text{Y}_2\text{O}_3\text{-ZrO}_2$
Column 14, Top of Bed (200x)

b. 9.25-Percent $\text{YRE}_2\text{O}_3\text{-ZrO}_2$
15-ft-Level Outer Segment (200x)

c. 9.25-Percent $\text{YRE}_2\text{O}_3\text{-ZrO}_2$
14-ft Level, Outer Segment (128x)

d. 9.25-Percent $\text{YRE}_2\text{O}_3\text{-ZrO}_2$
12-ft Level, Column 2 (Outer) (200x)

e. 9.25-Percent $\text{YRE}_2\text{O}_3\text{-ZrO}_2$
11-ft Level, Column 3 (Center)
(200x)

f. 9.25-Percent $\text{YRE}_2\text{O}_3\text{-ZrO}_2$
8-ft Level, Column 3 (Center)
(200x)

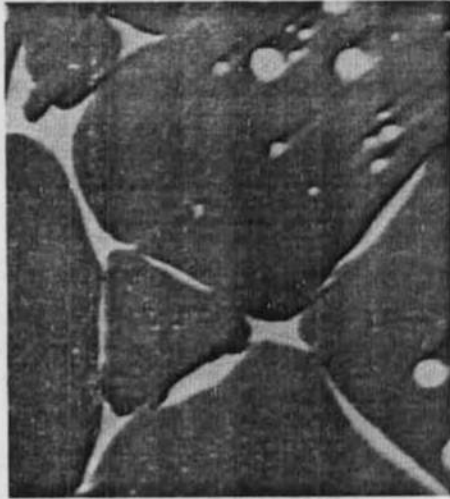
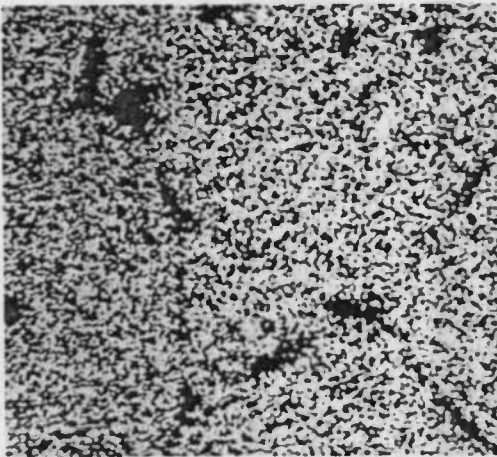
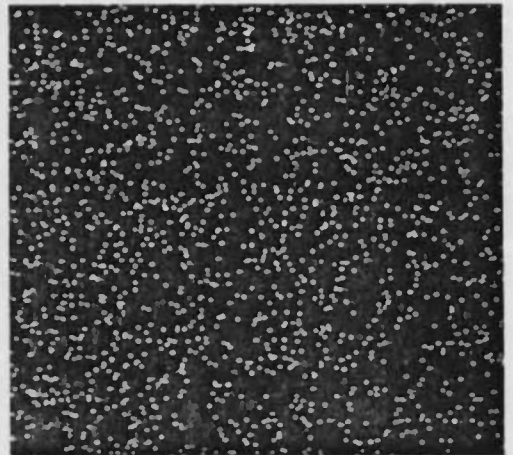
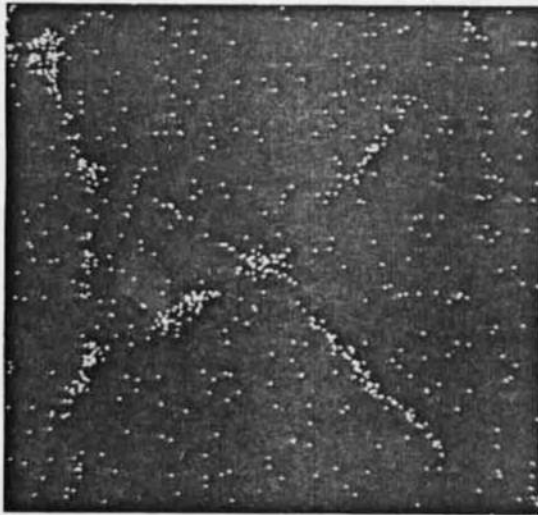
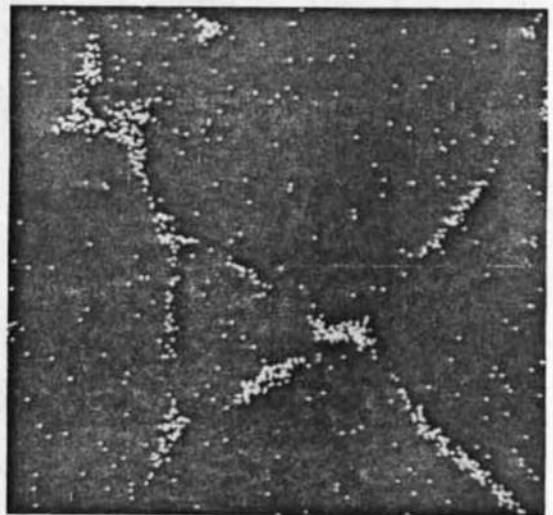
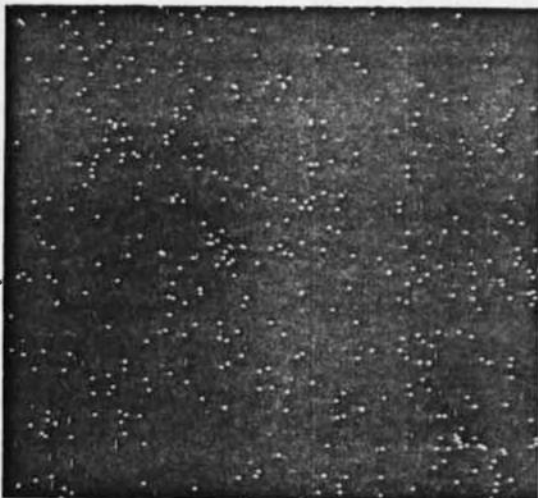
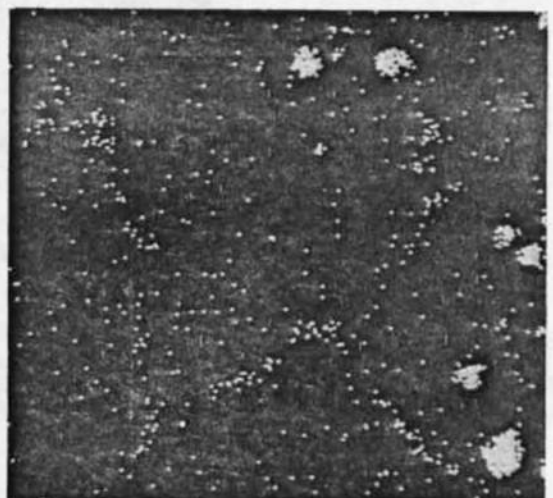
Fig. VII-2 Electron Microprobe X-Ray Photographs of 9.25 w/o YRE_2O_3 - ZrO_2
Sample from 12-ft Level

2. Microstructure-microprobe analyses identified the presence of a barium silicate glassy phase throughout the cubic ZrO_2 grain matrix in the cored blocks in the center section of the ZrO_2 block matrix (10- to 12-ft-level). The large increase in barium and silicon concentrations in brick from this region of the bed were also confirmed by bulk impurity analyses (SSMS and OES). The glassy nature of this second phase was inferred by (a) the rounded grain corners and boundaries of the primary ZrO_2 grains and (b) the lack of X-ray diffraction evidence for a crystalline phase.

a. Electron Backscatter Photo Showing
Second Phase between ZrO_2 Grains

b. ZrL_{α} (500x)

c. YLa (500x)

d. $Ba_{L\alpha}$ (500x)

e. $Si_{L\alpha}$ (500x)

f. $Ca_{L\alpha}$ (500x)

g. $Al_{L\alpha}$ (500x)

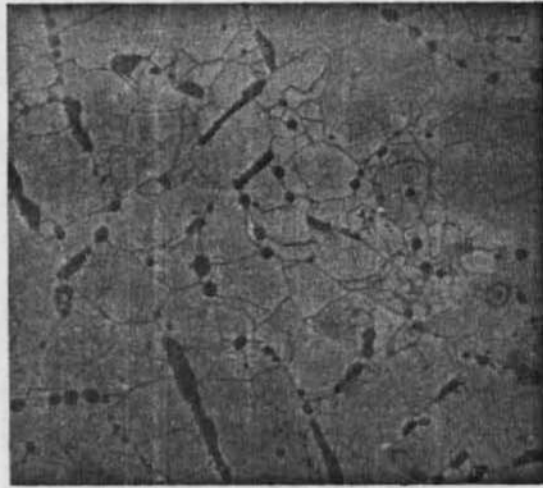
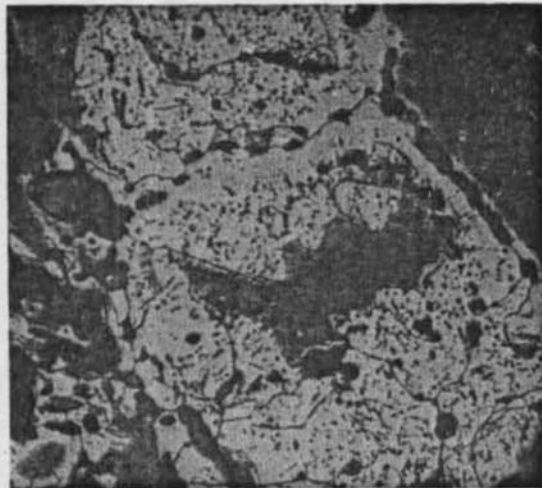
Fig. VII-3 Photomicrographs of 8-¼-percent Y_2O_3 - ZrO_2 Dome Brick
CC-9, Fourth Course

Only sections from the hot and cold surfaces of dome brick CC-9 were prepared for microstructure analysis. The hot face surface consisted of a wide range of grain sizes, all exhibiting very angular shaped boundary morphology (Fig. VII-3a). The cold face structure appeared to consist of more rounded grains, but still possessed a wide difference in sizes (Fig. VII-3b).

a. Hot Face Microstructure
(200x)

b. Cold Face Microstructure
(200x)
